Final Report

Assessment of Factors Limiting Salmon Production in Devil's Hole Creek

The Department of the Navy Submarine Base,
Bangor, Washington

December 2000

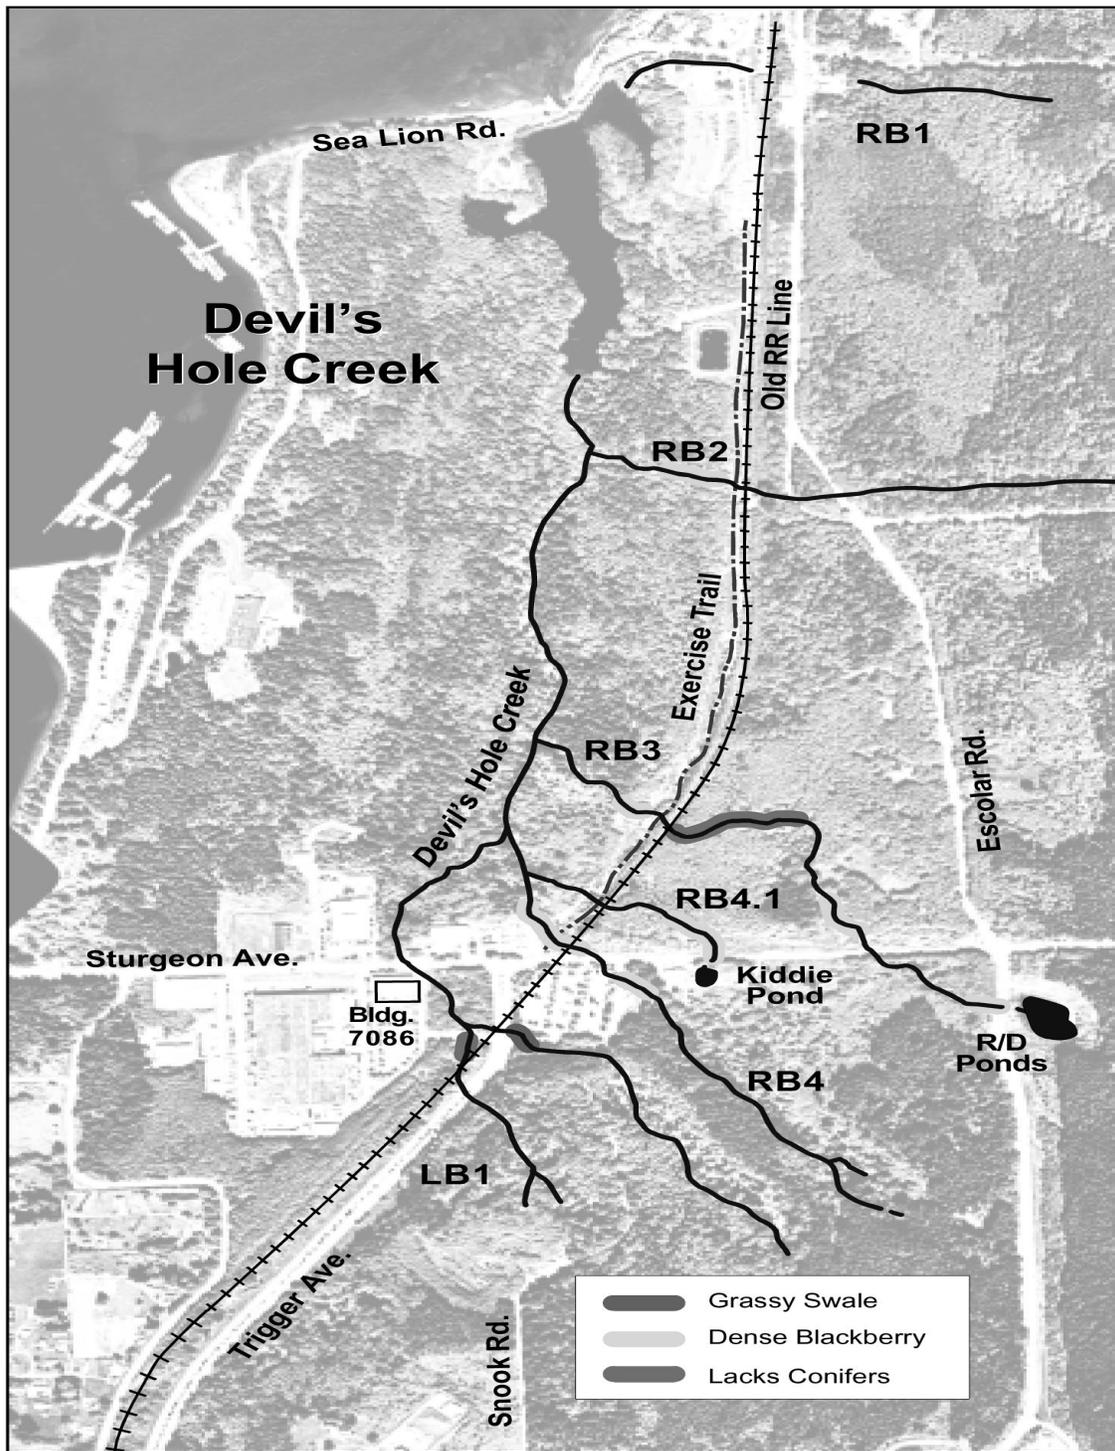
Figure 12. Problem Riparian Areas found in the Devil's Hole Watershed, 1999 and 2000.

Riparian condition in most areas was considered adequate for stream health. Most reaches had a mixed conifer/hardwood riparian zone consisting of mature or nearly mature trees. Conifer trees are particularly desirable in the riparian zone because they better provide for shade and large woody debris than other riparian taxa. Conifer composition was generally highest on the mainstem Devil’s Hole Creek, where it ranged from 5 to 80%, and averaged 38%. Conifer trees made up a high percentage of the riparian zone in Segments 4 and 5. Upstream, riparian zone modification in the vicinity of Sturgeon Street and naturally wet areas resulted in a much reduced conifer component.

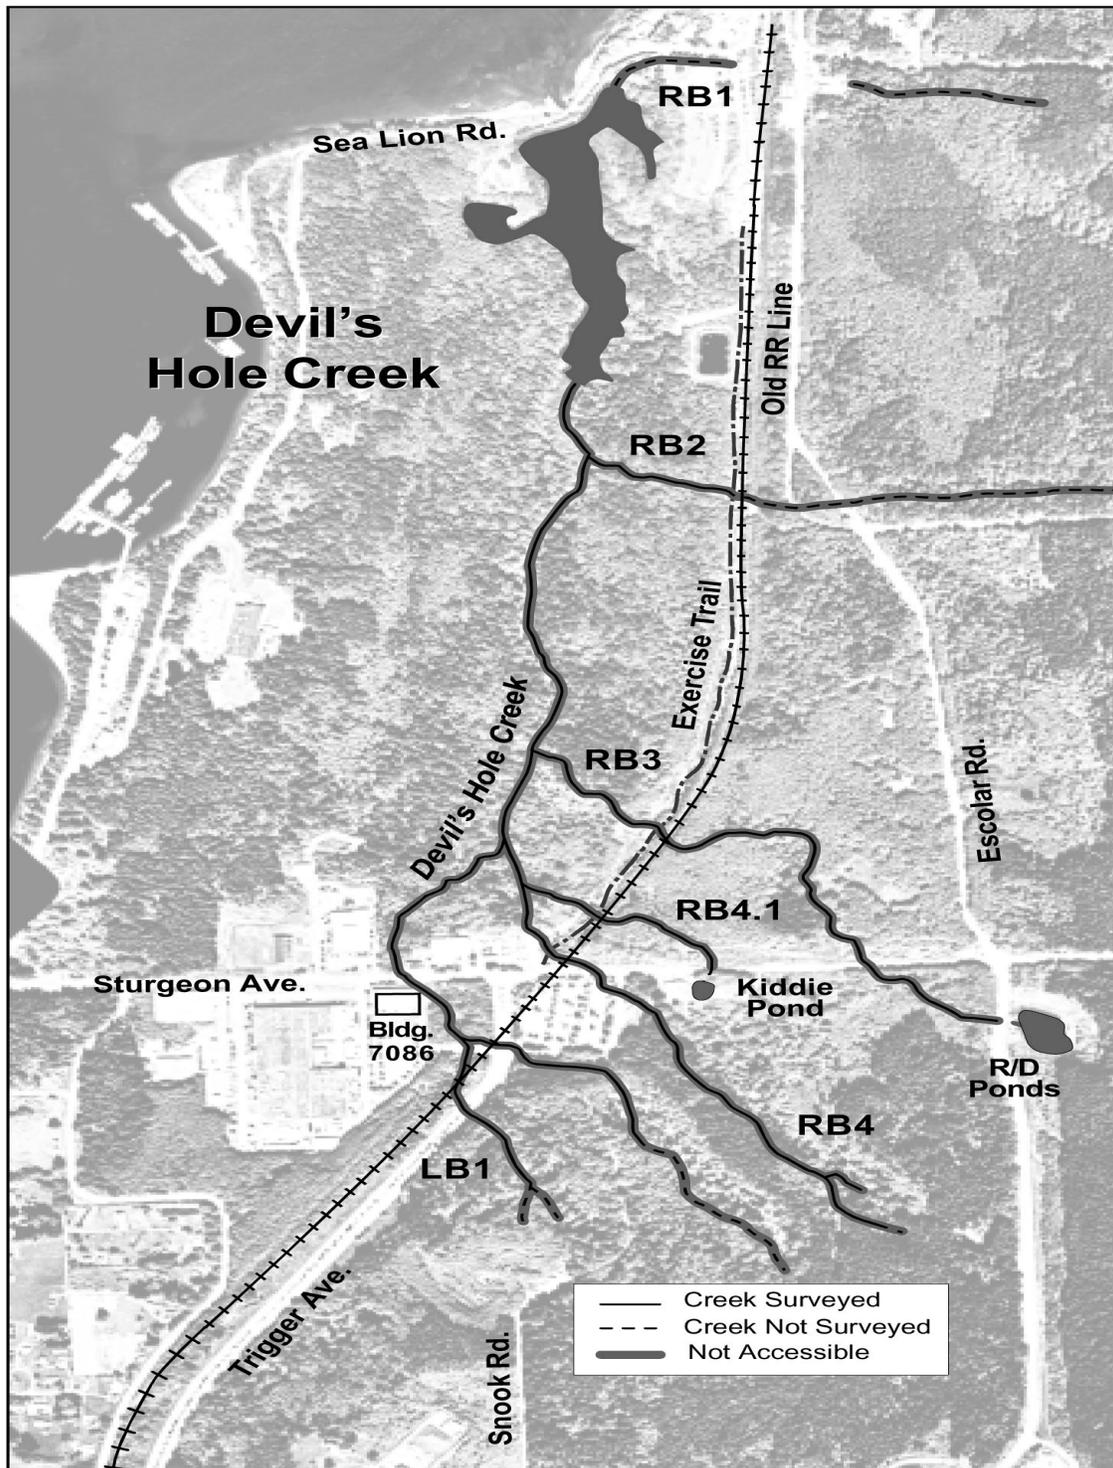
Figure 14. Access to the Devil's Hole Creek Watershed by Chum Salmon.

The drops between pools (0.9-ft), meet WDFW criteria for coho salmon and steelhead, but fail to meet criteria for chum salmon and cutthroat. Outmigrant trapping in 1999 and 2000 indicated very low levels of coho, cutthroat, and steelhead are present in the basin. No chum salmon have been found over this two-year period. We believe this fishway is a blockage for chum salmon access, including the threatened Hood Canal summer chum stock (Figure 14).

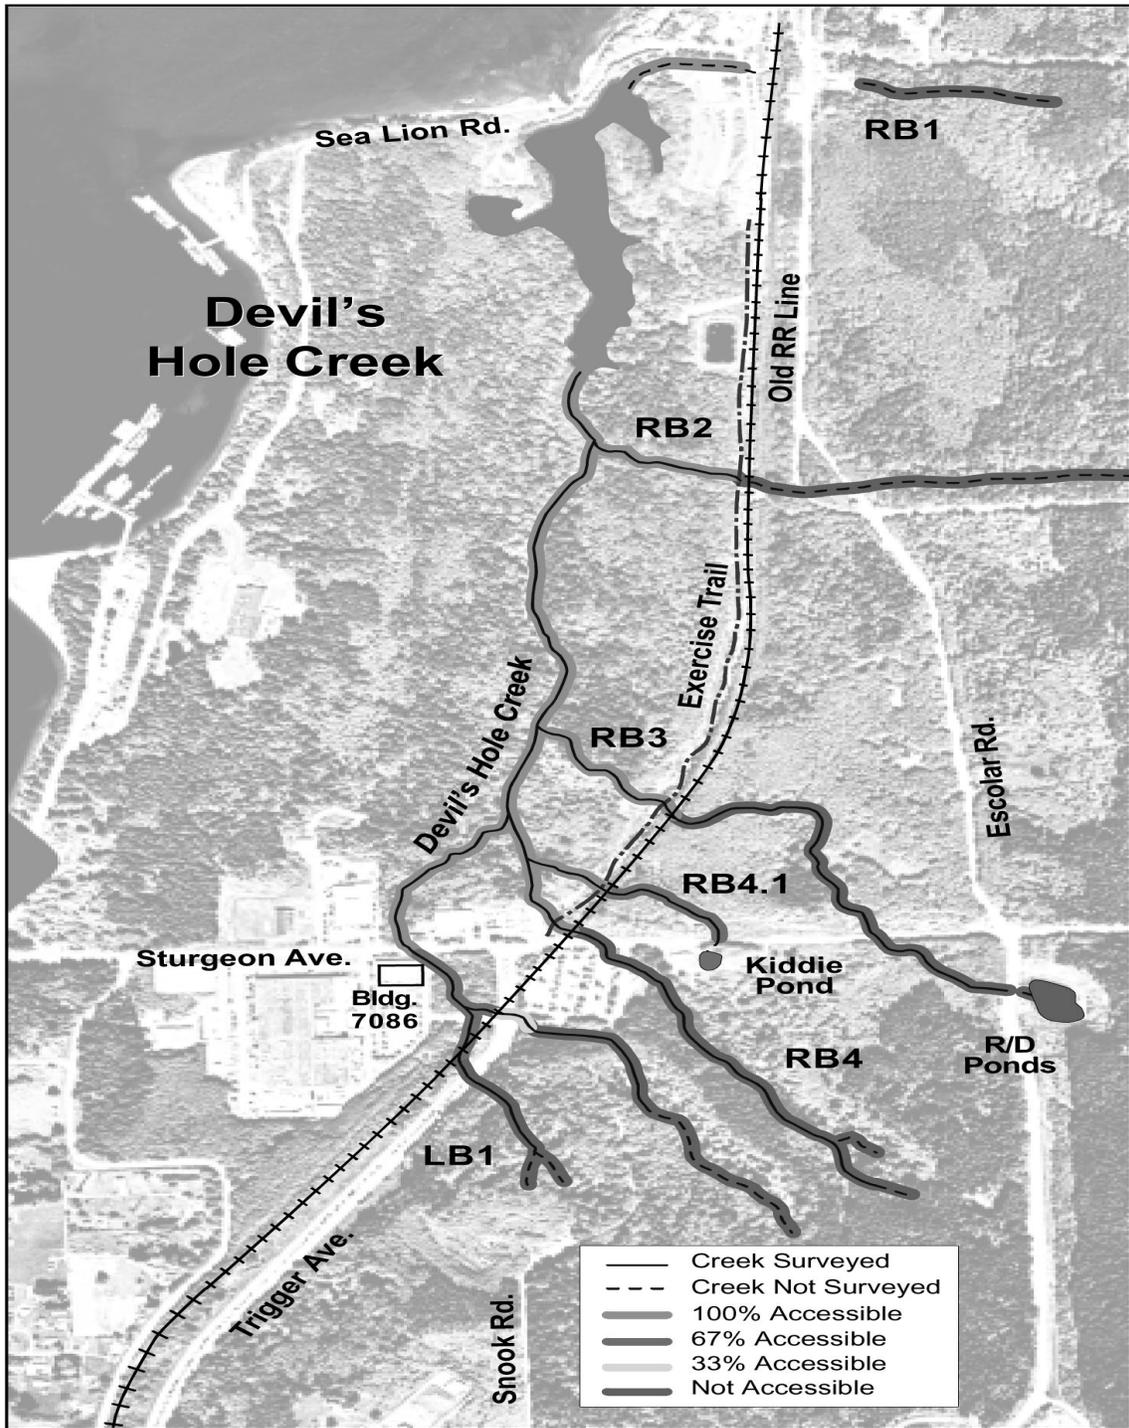
Figure 15. Access to the Devil's Hole Creek Watershed by Coho Salmon, Cutthroat, and Steelhead.

Culverts in the Devil's Hole watershed were found to substantially effect the amount of habitat available for anadromous salmonids. Culvert passability was described in four categories: 100% passable, 67% passable, 33% passable, and 0% passable (total blockage) and was assessed for coho, steelhead, rainbow trout, and cutthroat trout passibility. Devil's Hole Creek and most of its tributaries were found to be totally blocked to coho, steelhead, and anadromous cutthroat trout use upstream of the old railroad line or Trigger Avenue (Figure 15). Only one tributary, RB4.1

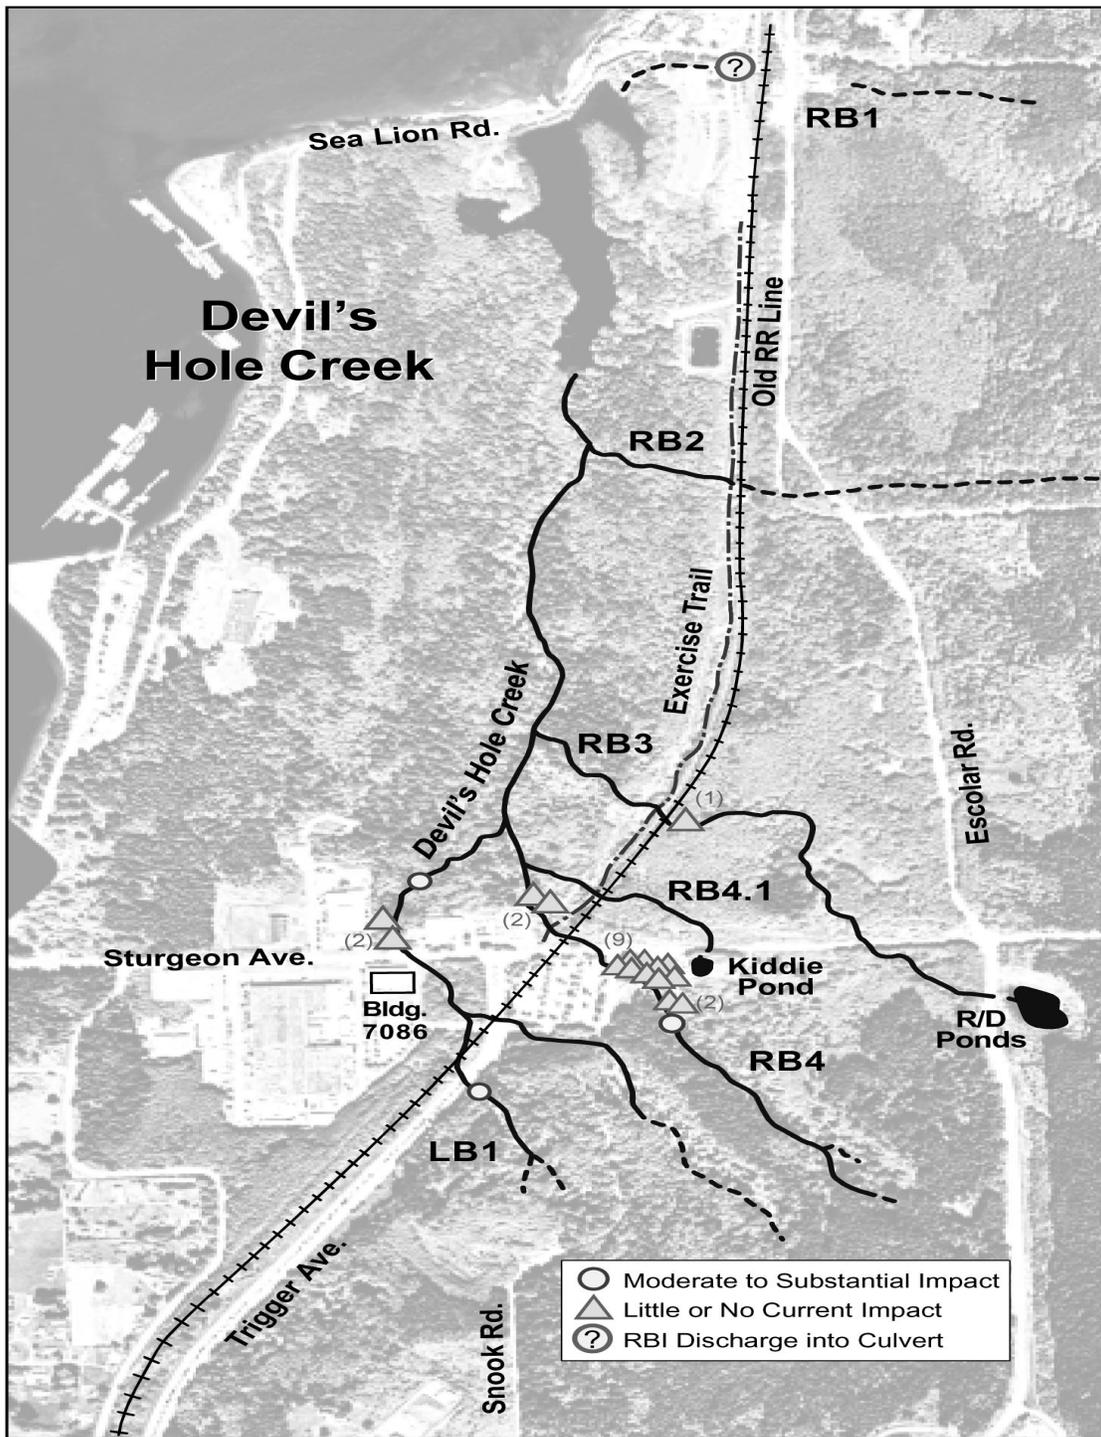
Figure 16. Location and Current Impact Level of Outfall or Pipe Crossings within the Devil's Hole Watershed, 2000.

Twenty outfalls or pipe crossings were identified during the survey (Table 9). The majority of the outfalls resulted in very minor to no impact to the bank or stream bed. More substantial impacts were noted at four locations (Figure 16).

The greatest impact was found from an outfall located on Devil's Hole Creek, 215-meters downstream from the Sturgeon Street culvert. Effluent from an 18-inch corrugated steel pipe on the left bank has scoured a 2.2-meter channel to the creek. The pipe is perched above the stream and has scoured a 5-meter square hole below the discharge point.
